UNDERWATER FACILITIES INSPECTIONS

NAVAL STATION

NORFOLK, VA.

SEPTEMBER 1981

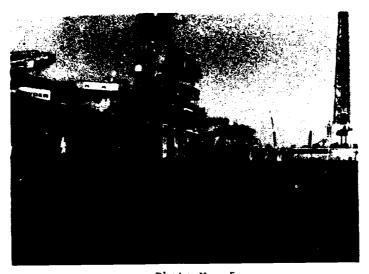
Photo No. 5
Pier 12 - Fender system and outboard piles (typical).

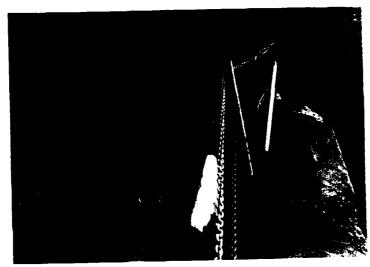
Photo No. 17

In general, the bulkhead was found to be in good condition below the water line and fair condition above the water line and along the cap structure. The location of defects in the area of maximum moment indicates that the wall has been overloaded in some regions. The concrete sheet pile joints appear to be leaking.

Bulkhead CEP-111 - Damage at western end; looking south (Station 0+00).

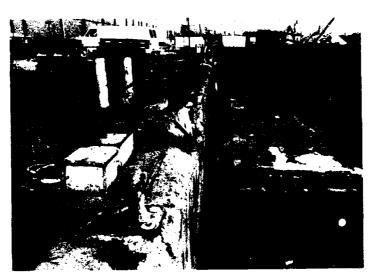
Photo No. 18

Bulkhead CEP-111 - Photo shows section of bulkhead with damage to cap in foreground (Station 2+50).

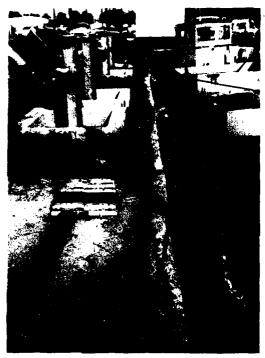
Photo No. 21
Eastern end of Bulkhead CEP-111.
